Reference: **Environmental Assessment**
Chase Storage
SE Commerce Ave, Stuart, Martin County, FL
Parcel ID # 38-38-41-002-105-00000-9

ENVIRONMENTAL ASSESSMENT

Parcel ID 38-38-41-002-105-00000-9
Chase Storage
Stuart, Florida

Project No. 19-213
Date: February 20, 2019

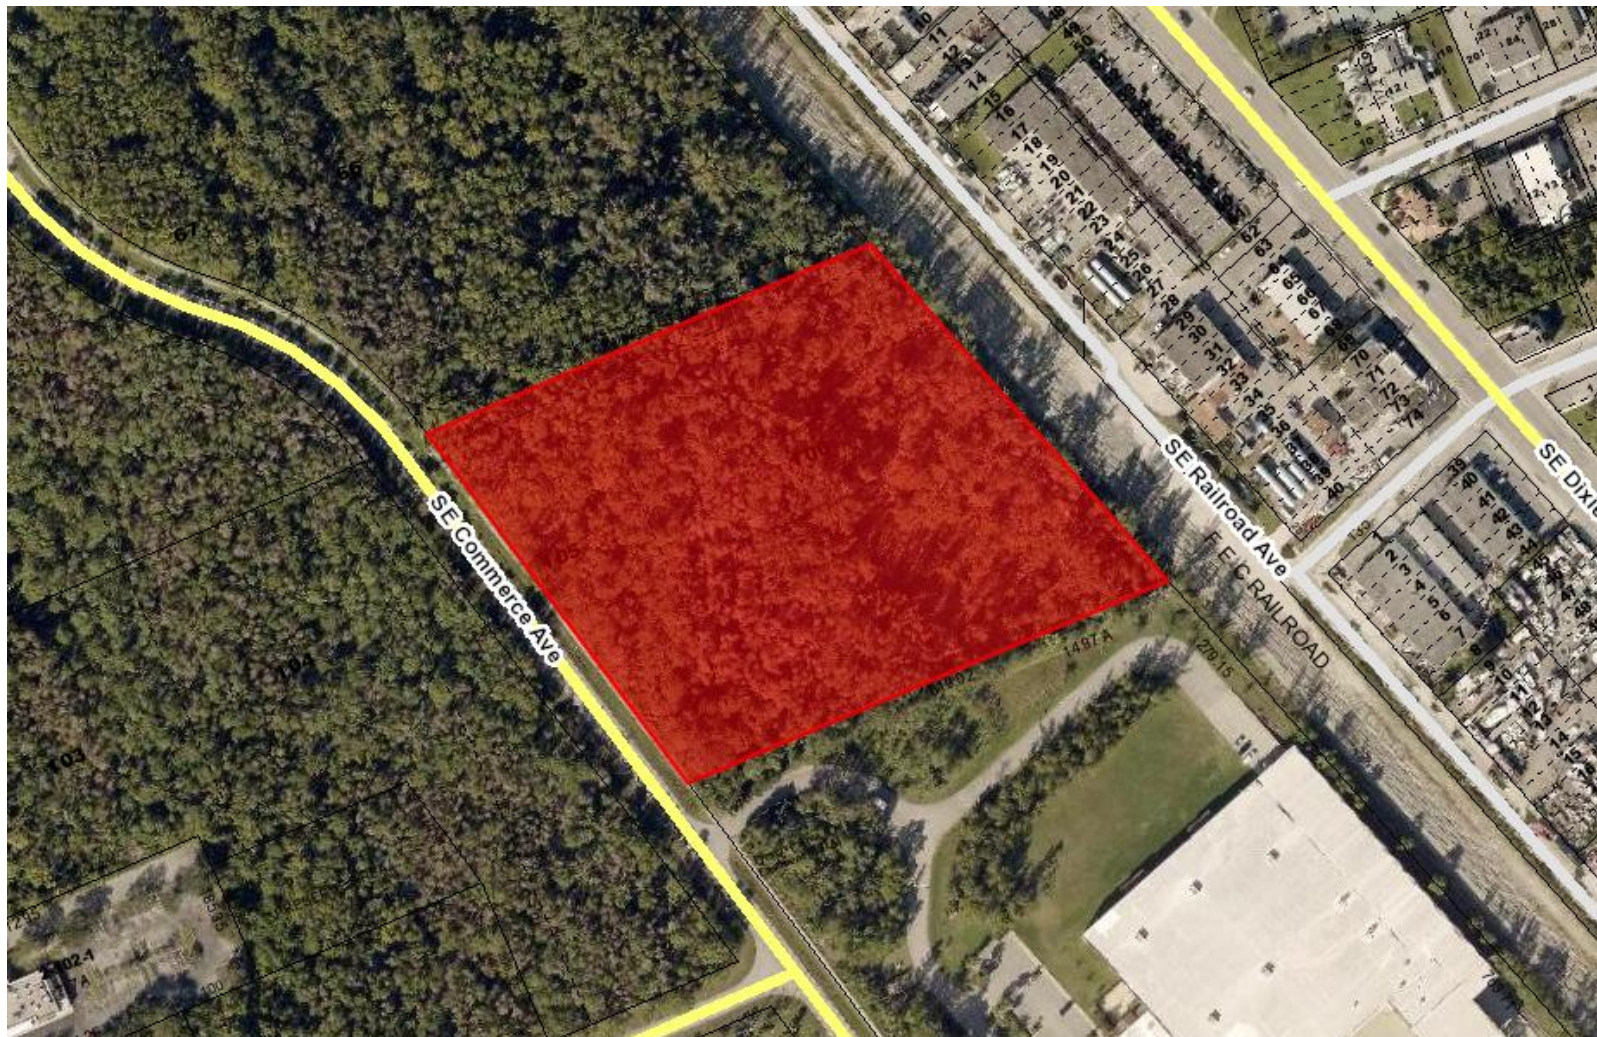
Property Appraiser Map

According to the Martin County Property Appraiser's Report, the subject property has a land use code of 1000 Vacant Commercial.

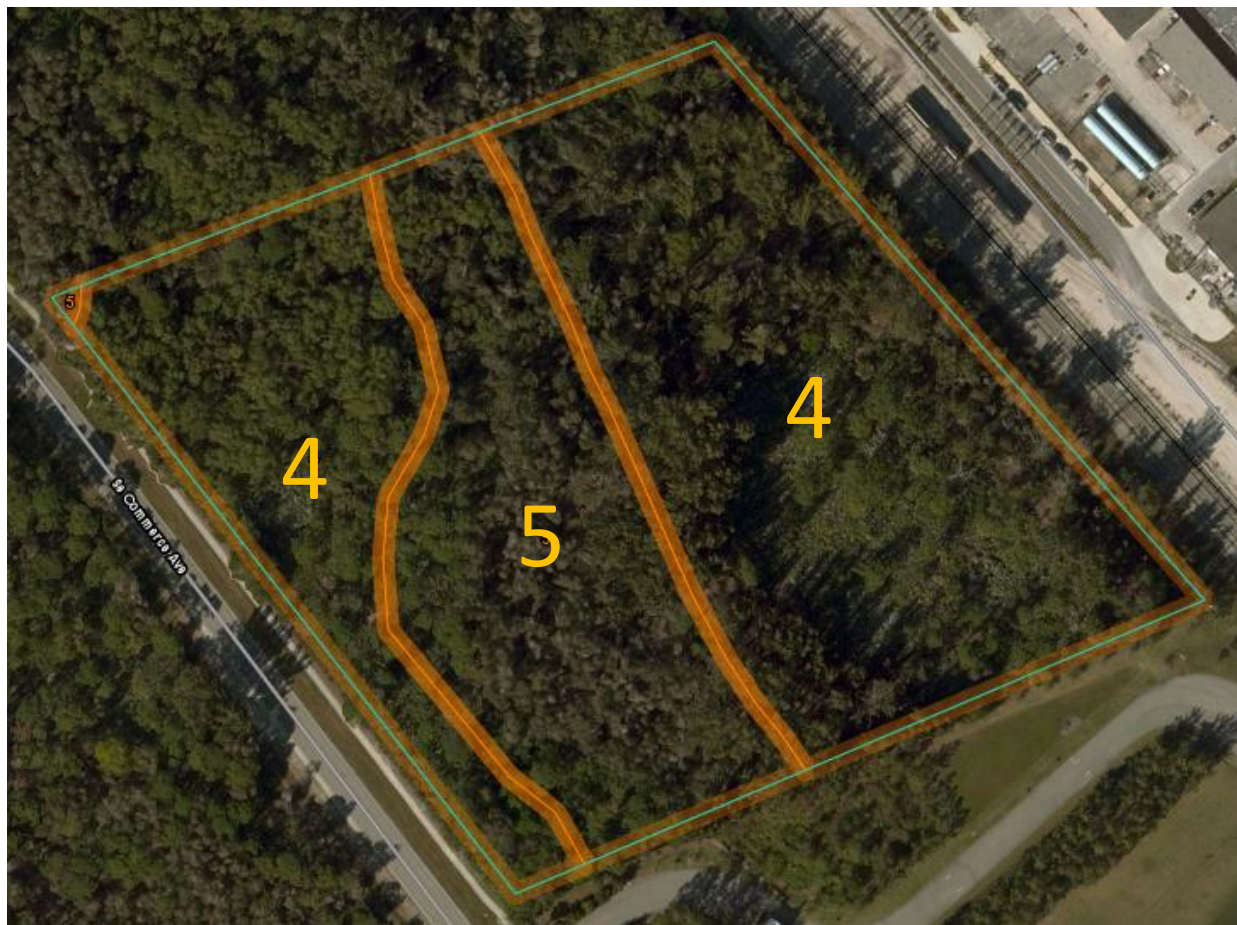
Soil Map

Waveland sand- This is a nearly level, poorly drained soil found in broad open areas of the flatwoods. The natural vegetation associated with this soil type is slash pine and an understory of saw palmetto, gallberry, fetterbush, running oak, and dwarf huckleberry. Grasses are pineland threeawn, bluestem and panicum. Typically, the surface layer is dark gray sand with a light gray and grayish brown subsurface layer. Under natural conditions, this soil is not suited to cultivate crops or for pasture because of ponding. However, if intensive management, soil improving measures and a good water control system are implemented, the soil is suitable for vegetable crops and pasture.

Immokalee Fine sand- is poorly drained soil is found in broad areas of flatwoods. Typically the surface layer is very dark gray fine sand about 6 inches thick. The subsurface layer extends to a depth of 35 inches and is fine sand. The seasonal high water table in Immokalee soil is at a depth of 6 to 8 inches from June through September. During the remainder of the year it is typically at a depth of 18 to 40 inches. Natural vegetation consists of slash pine and scattered oak with an understory of saw palmetto, gallberry, fetterbush,

Lawnwood Fine sand, depressional- This poorly drained soil is in the depressions of flatwoods. The typical surficial layer is fine gray sand followed by light gray and white fine sand below. The soil is typically ponded for six months of a normal year. The soil is only suited for pasture under intense management.

Map Unit Symbol	Map Unit Name	Acres in AOI	Percent of AOI
4	Waveland and Immokalee fine sands	5	70.4%
5	Waveland and Lawnwood fine sands, depressional	2	29.6%
Totals for Area of Interest		7	100.0%
